Phase 1 Milestone Report

Admiral Condominium

**8750 South Ocean Drive
Jensen Beach, FL 34957**

April 24th, 2023

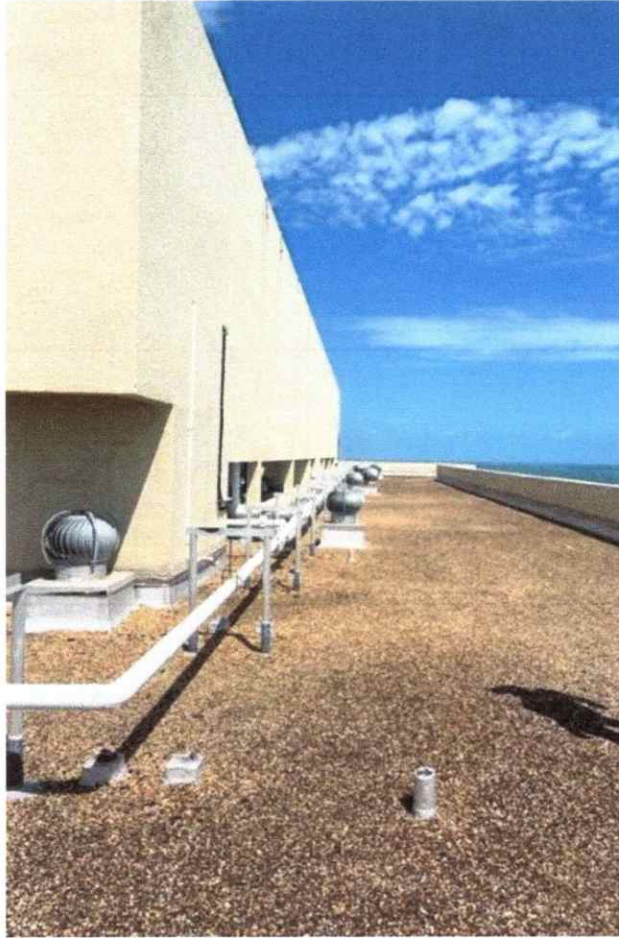
Roof Figure 1.

- **Roofing:** The roof consists of a BUR system with gravel. The roofing system and all associated mechanical equipment are supported by a concrete deck. A recent moisture survey was completed in December 2022. From the survey, over 70% of the total area contained moisture and from the core drillings the insulation boards contained more than 5% moisture. A roofing project is set to start later this year. SEP is in the process of making project specifications and bid documents.

Based on our findings, we recommend that the Owners initiate a replacement project on the roofing system, due to the results found in the moisture survey and age of the roof. We also recommend that the Owners plan for a balcony project to address the problem areas found during the survey. SEP will be preparing drawings and specifications for those repairs.

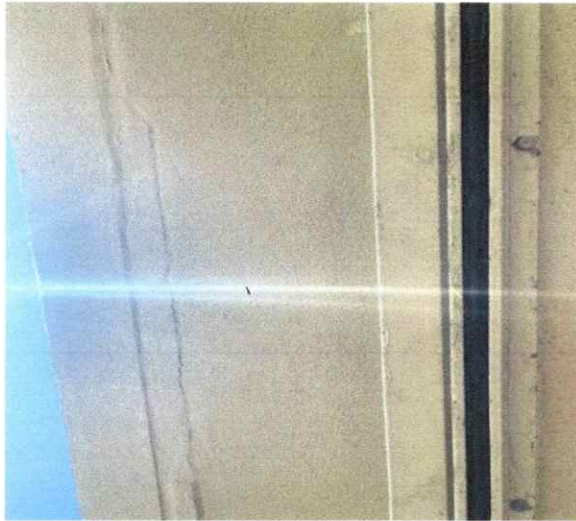
- **Balconies:** The balconies are constructed using rebar and post tension cables. In most cases, the balconies show little distress except for some units where the edge has some deterioration. A recent balcony survey was completed in December 2022, which consisted of visually and acoustically inspecting all the balconies (**Figure 3**). This included the slab, the edges, and the ceilings. A total of 86 linear feet of edge was discovered to have damage, along with 77 square feet of partial depth repairs on the slab. The balconies are all covered by tiles, and delaminated areas were discovered, about 963 square feet. SEP deems that the area is safe and poses no immediate danger to the residents. A balcony project is recommended to start within 12 months. The repair project for all the balcony repairs was estimated to be about \$197,000.

Figure 1. Balcony Edge

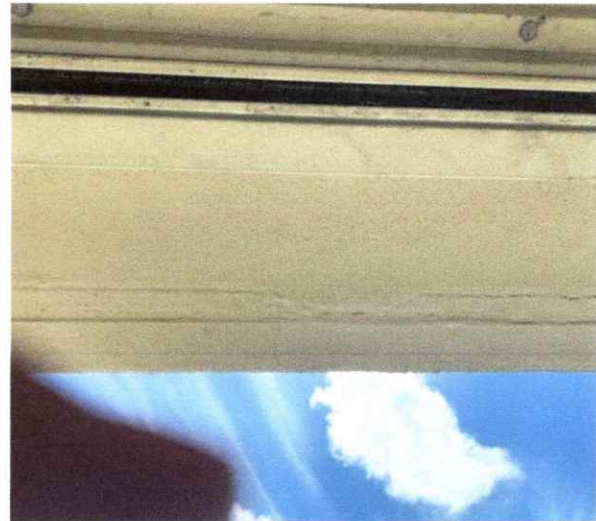
Figure 2. Balcony Edge

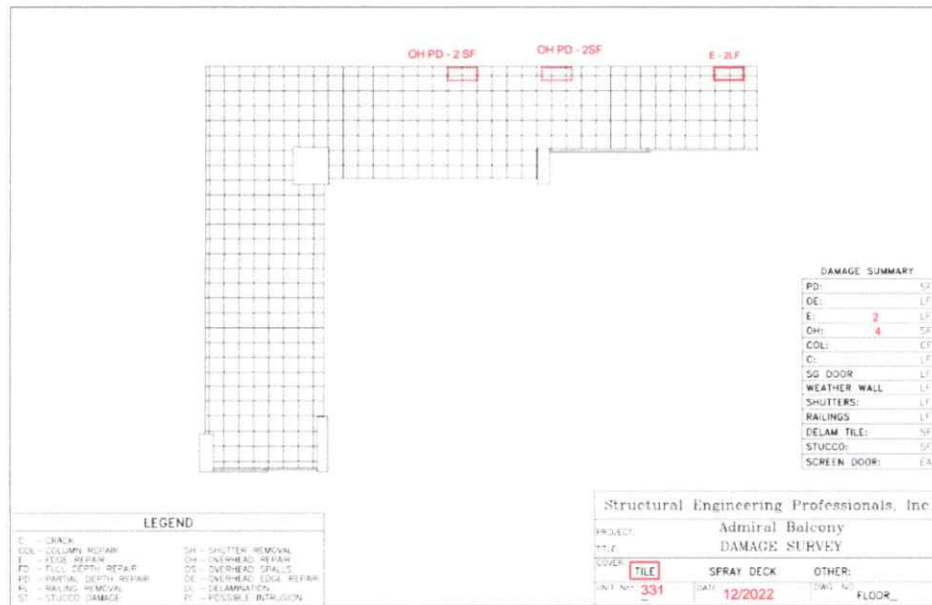
Figure 3. Sample Balcony Survey Map

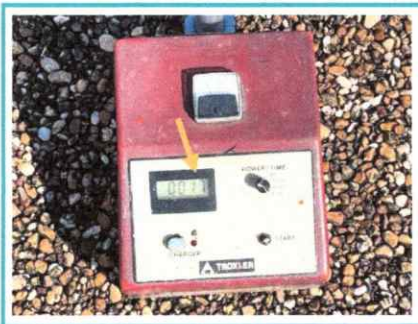
Core Cut No. 1

Troxler moisture gauge indicates a subsurface hydrogen value of “17”. Numeric value indicates amount of hydrogen encountered by device. Higher hydrogen values represent water in system.

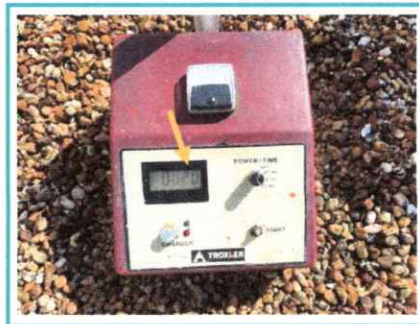
Core Cut No. 2

Troxler moisture gauge indicates a subsurface hydrogen value of “20”. Numeric value indicates amount of hydrogen encountered by device. Higher hydrogen values represent water in system.

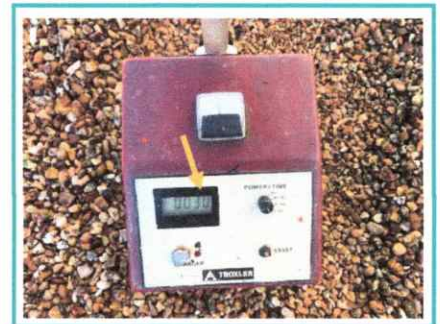
Core Cut No. 3

Troxler moisture gauge indicates a subsurface hydrogen value of “30”. Numeric value indicates amount of hydrogen encountered by device. Higher hydrogen values represent water in system.

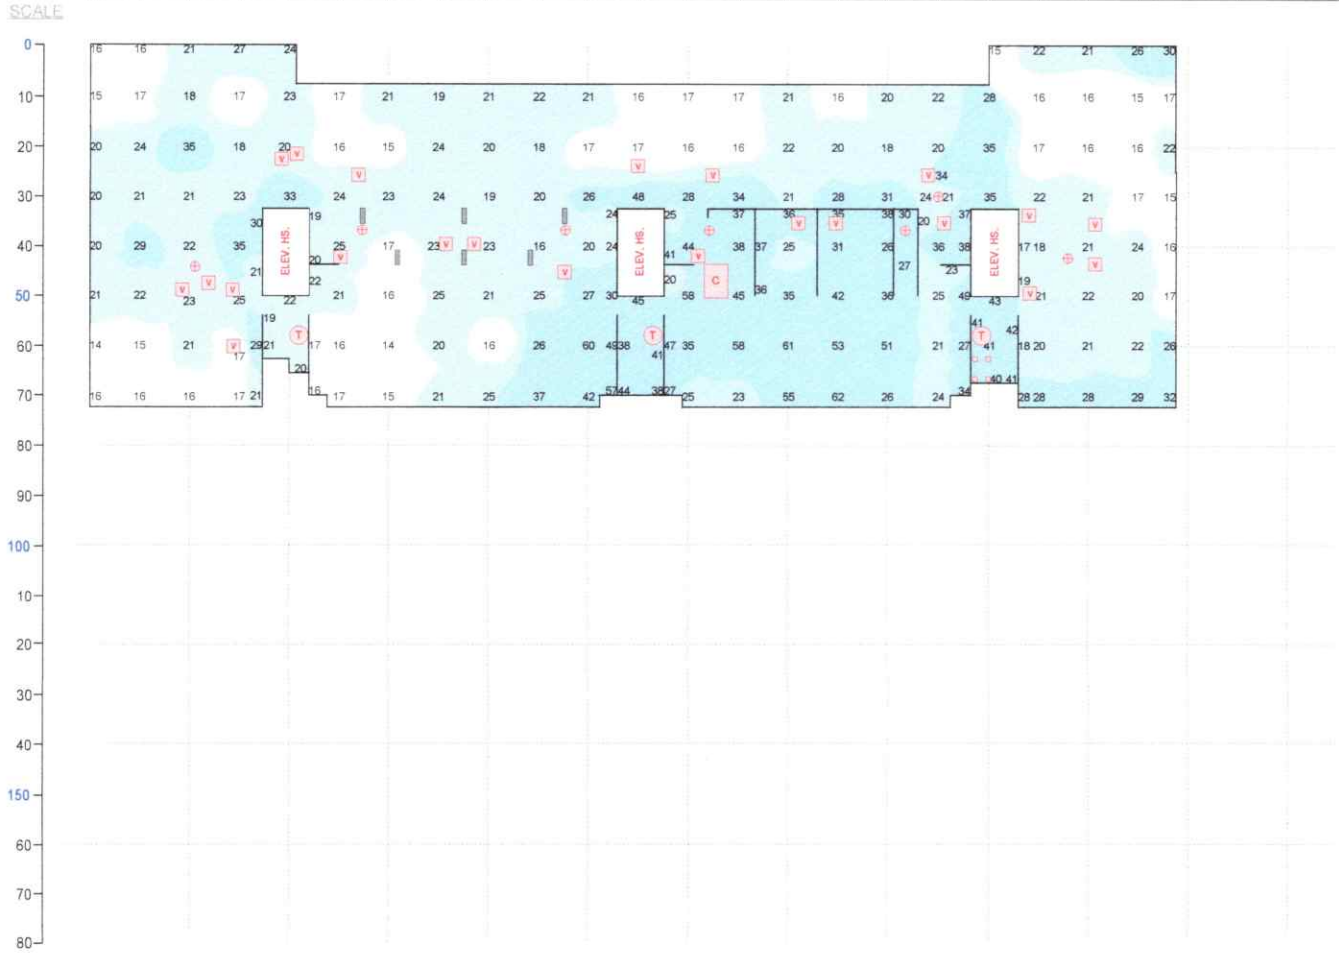
Graphic Sheet

As shown on the enclosed graphic interpretation sheet substantial areas of subsurface water were detected within the roof system materials. Typically detected subsurface water will either affect the membranes (inner ply), or underlying insulation materials. Following the path of least resistance, subsurface water can travel under the insulation material, or along the concrete deck. This water could eventually enter the facility through cracks in the decking, or through mechanical penetrations (i.e., vents, stacks, conduits).

The amount of water affected roof materials is well above the twenty-five percent threshold on the tested roof system and should be completely removed and replaced as per the building code.

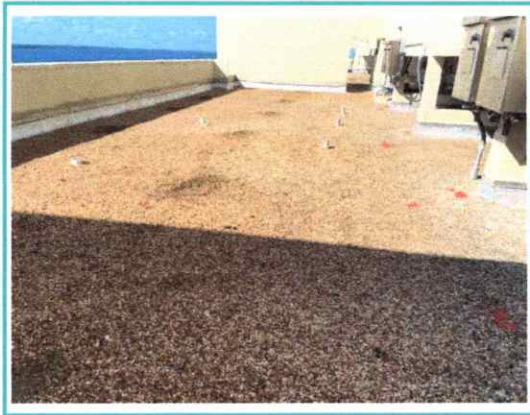
9. Large area of high concentration subsurface water, wet

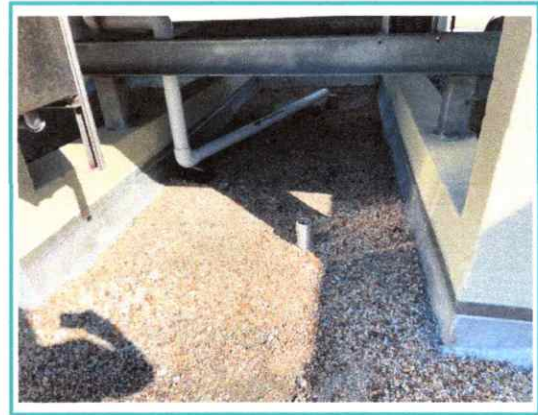
10. Additional areas of subsurface water under C. Twr.

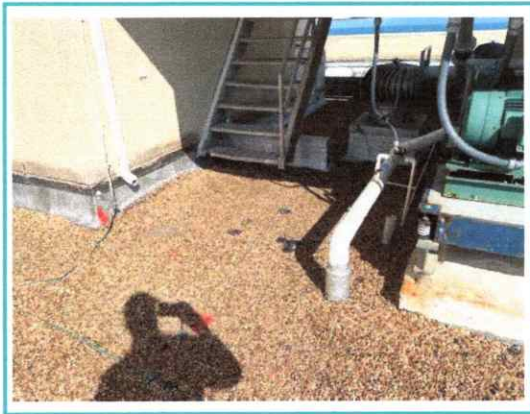
11. Additional areas of subsurface water under C. Twr.

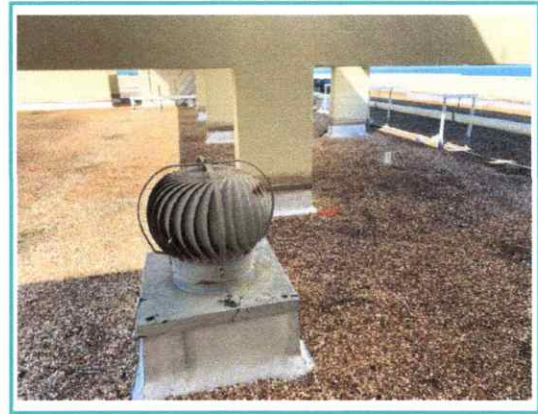
12. Subsurface water continues within center of roof, wet

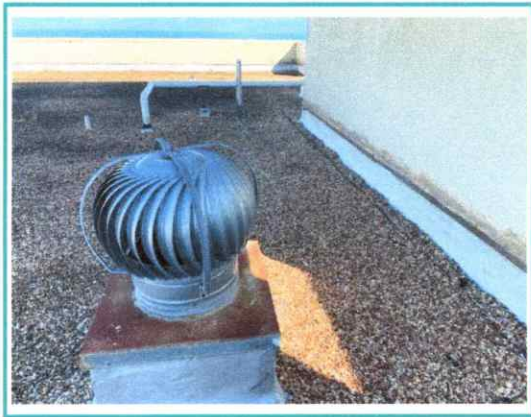
13 Additional areas of subsurface water along N. end Elev.

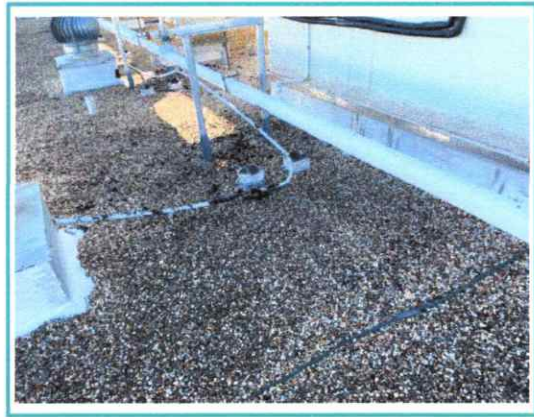
14 Subsurface water detected at base of Elev. Hs. & stands

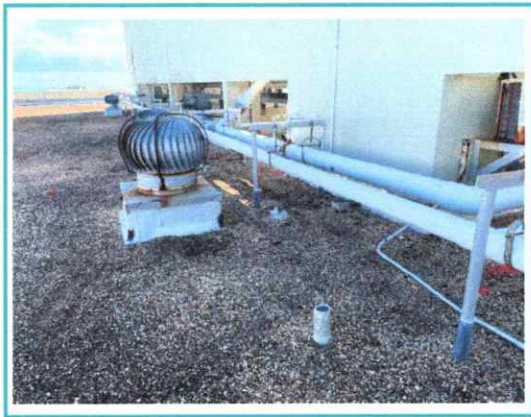
15 Subsurface water detected at base of Elev. Hs. & stands

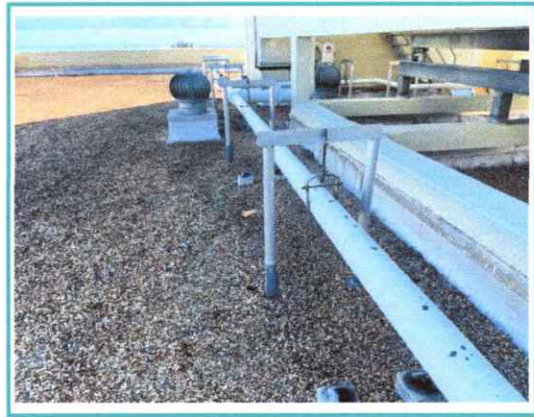
16 Subsurface water continues surrounding pipe stands
